## How to use the NOx sensor emulator NOXEM 129 | 130. Part 2

Depending on your preferences you can proceed re-adaptation of the engine using ISTA D/+ or INPA.

## Re-adaptation of the engine using ISTA D/+

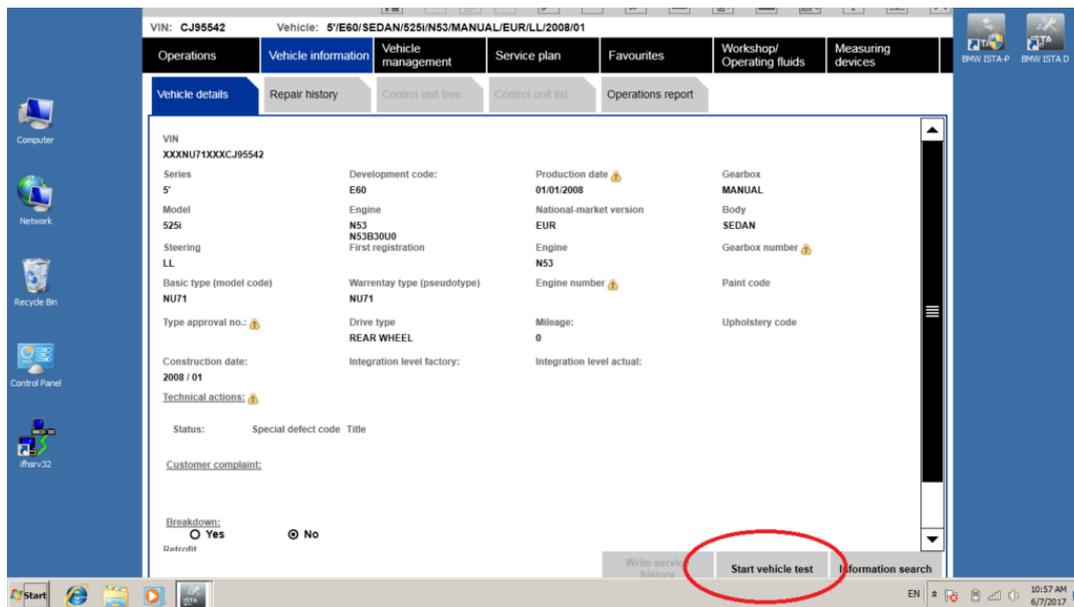
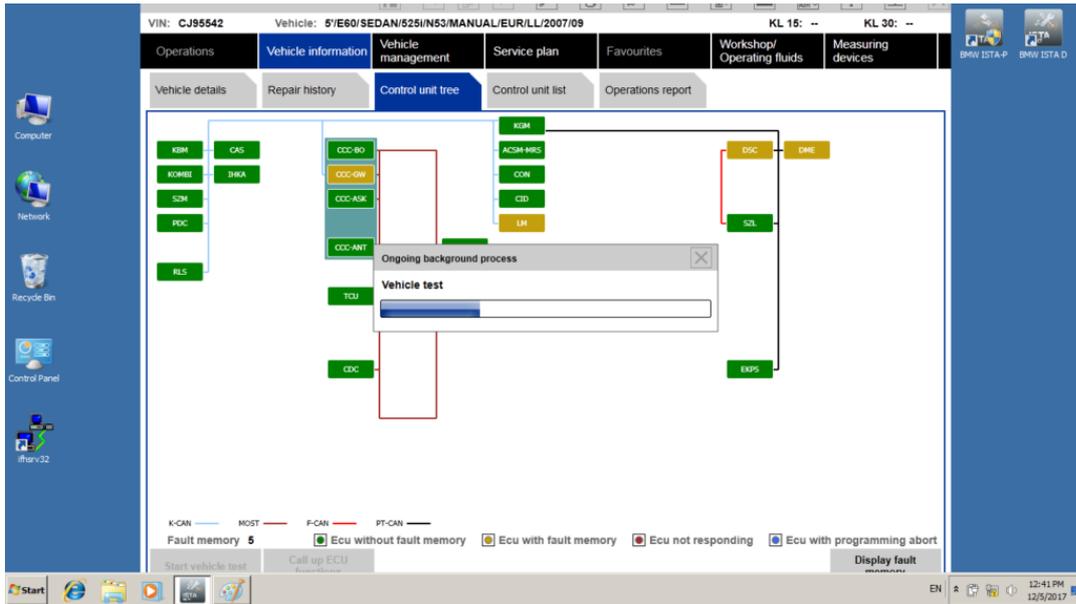
1. Start new session in ISTA D/+, perform the identification of vehicle and a test:

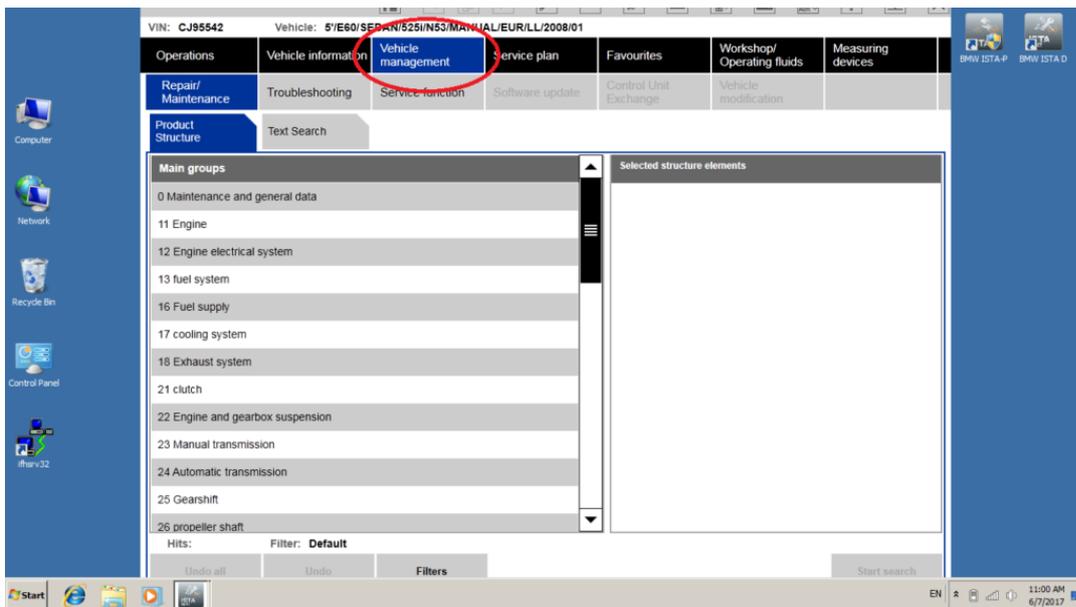
2. open menu *Vehicle management*:

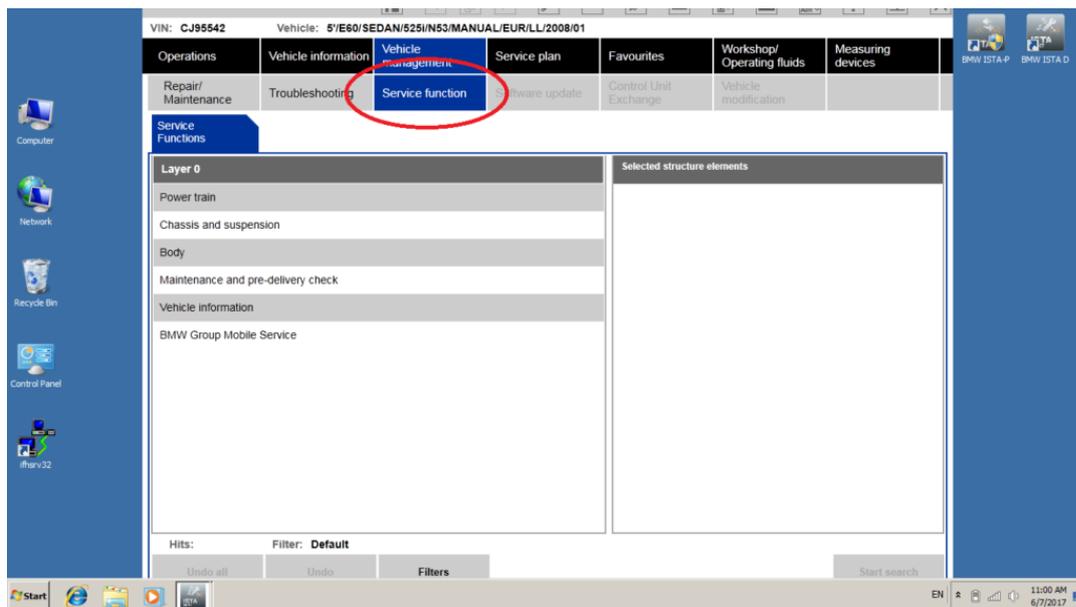
3. open menu *Service function*:

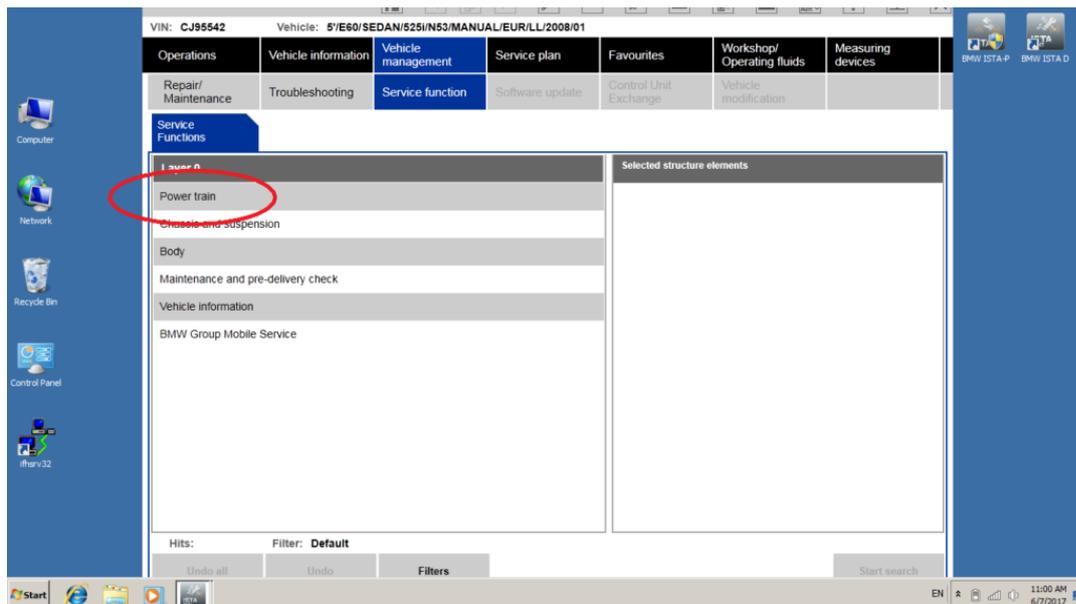
4. open sub-menu *Power train*, press *Start search*:

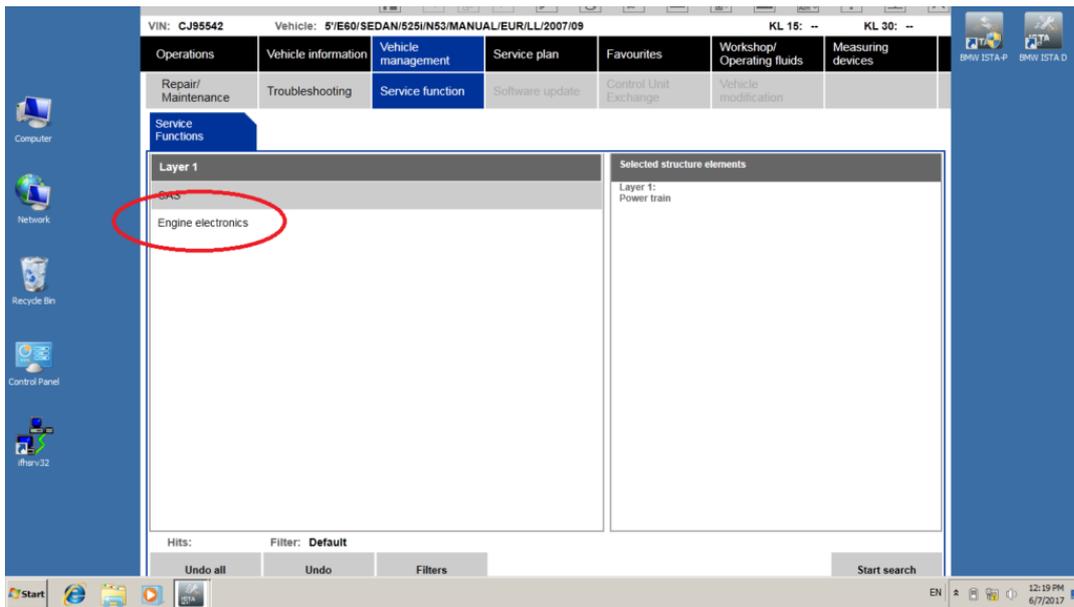
5. open sub-menu *Engine Electronics*:

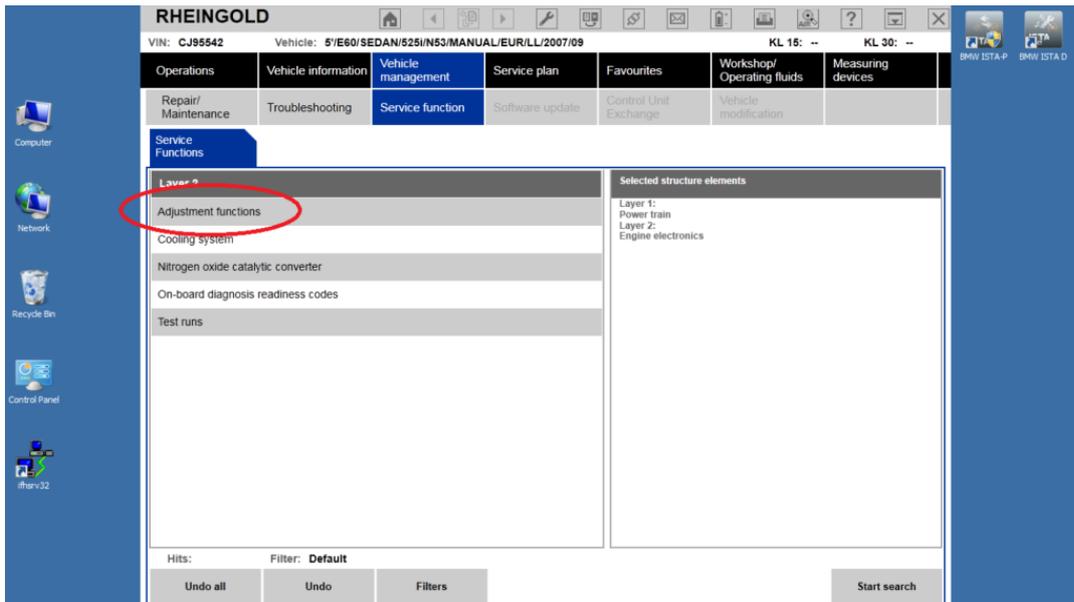
6. open sub-menu *Adjustment functions*:

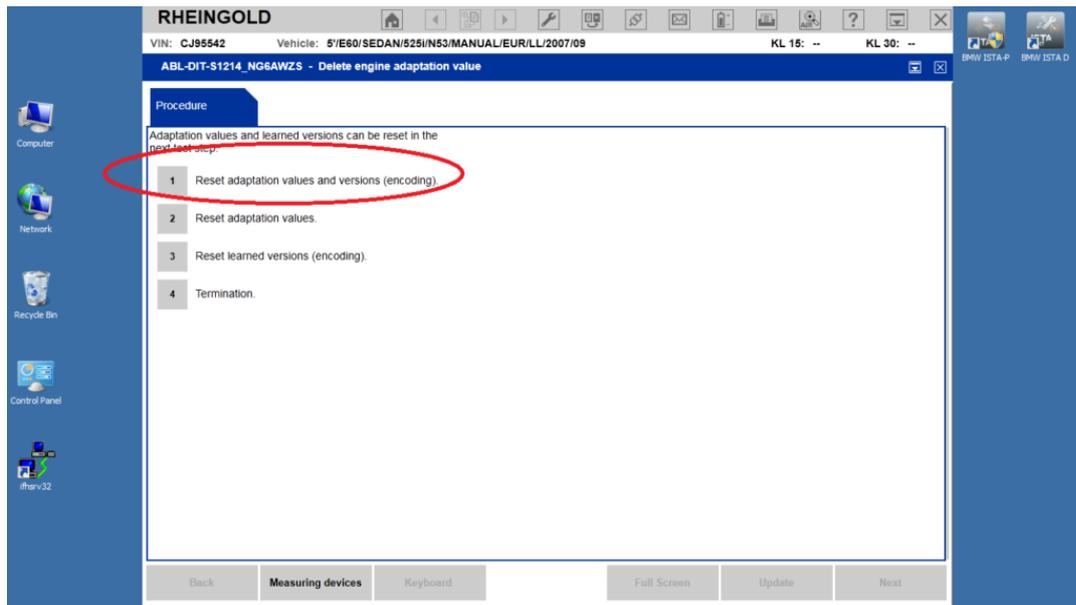
## 9. Select *Reset adaptation values and versions (encoding)*

Follow instructions on the screen.

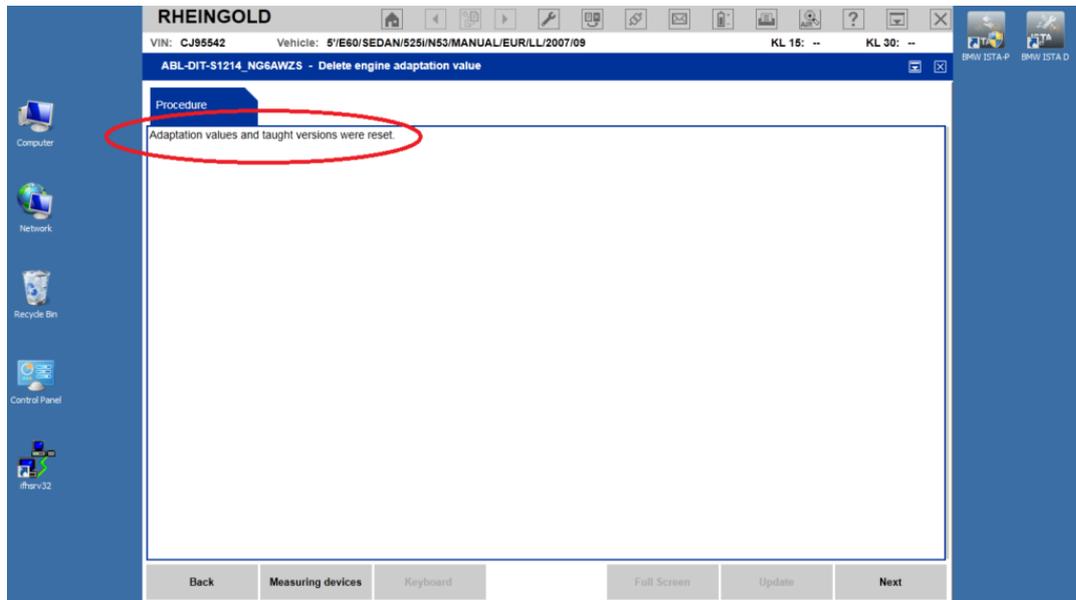
**Follow the instructions very carefully!** If deleting of adaptations was successful, you will see notice "Adaptation values and taught versions were reset". If ISTA D/+ does not displays notice "Adaptation values and taught versions were reset" after the attempt to delete the adaptations, **repeat the procedure once again.**

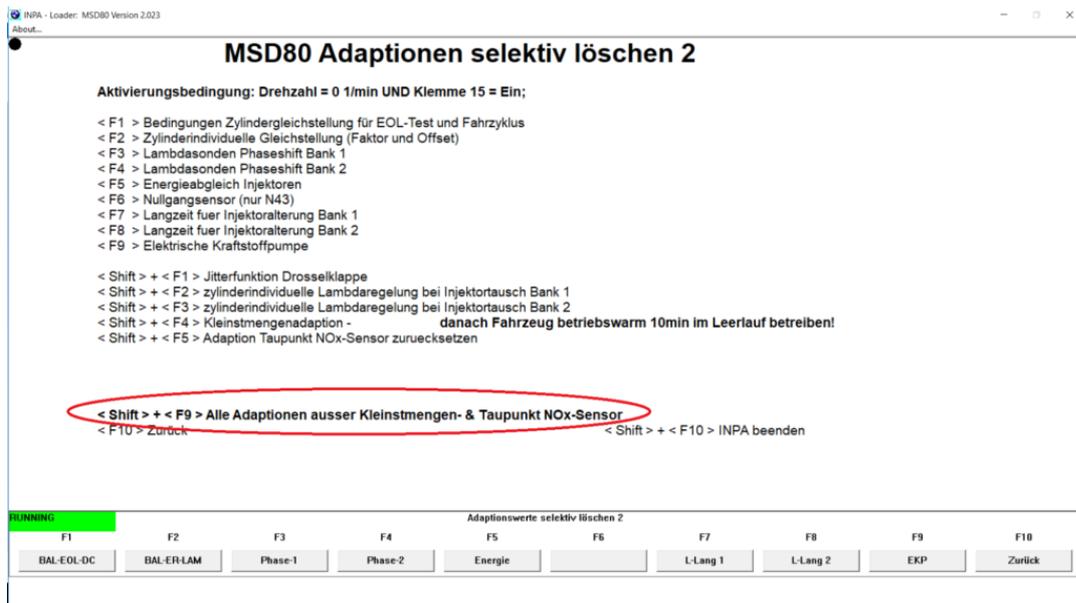
1. open INPA adaptation menu, 2nd group: ../F8/F2

a) delete the adaptations (status: ignition on; engine off), pressing Shift+F9;

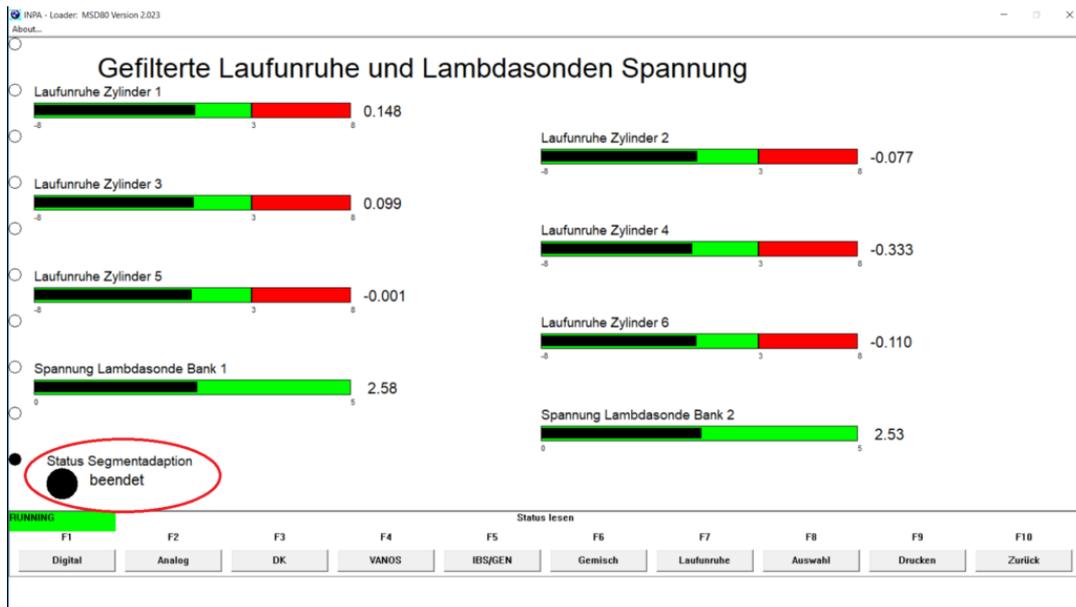
2. Insert the key, turn on the ignition, open Rough run menu ../F5/F7

**Learnbit of flywheel adaptations has to be uncolored (white).** If learnbit of adaptations is colored, repeat point 1.

After 5 .. 10 seconds learnbit of flywheel adaptations has to be colored in black. If learnbit stays uncolored, repeat from point b.

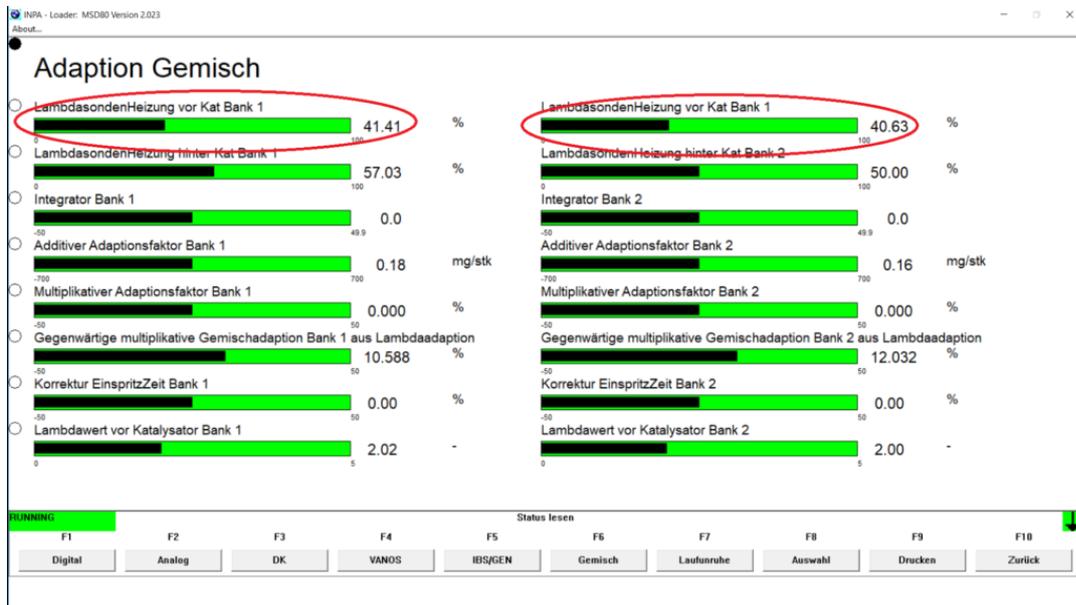
a) open INPA fuel mixture menu ../F5/F6;

b) after a little while the MSD80 has to start to warm up the wide-band probes, PWM of them has to increase to 30 .. 60%;

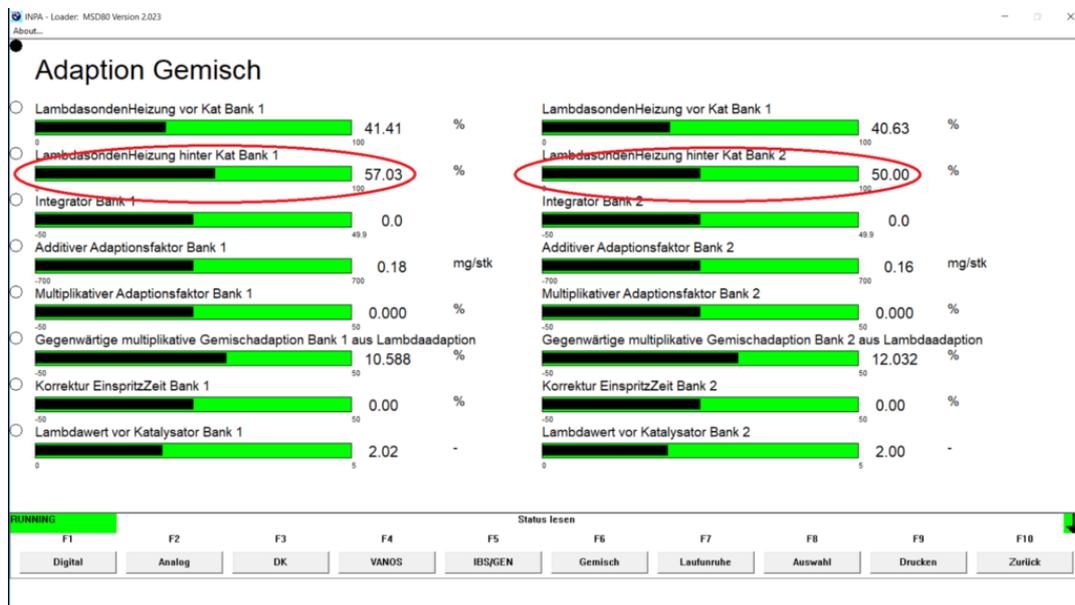
a) open INPA fuel mixture menu ../F5/F6;

b) after a little while the MSD80 has to start to warm up the control probes, PWM of them has to increase to 30 .. 60%;

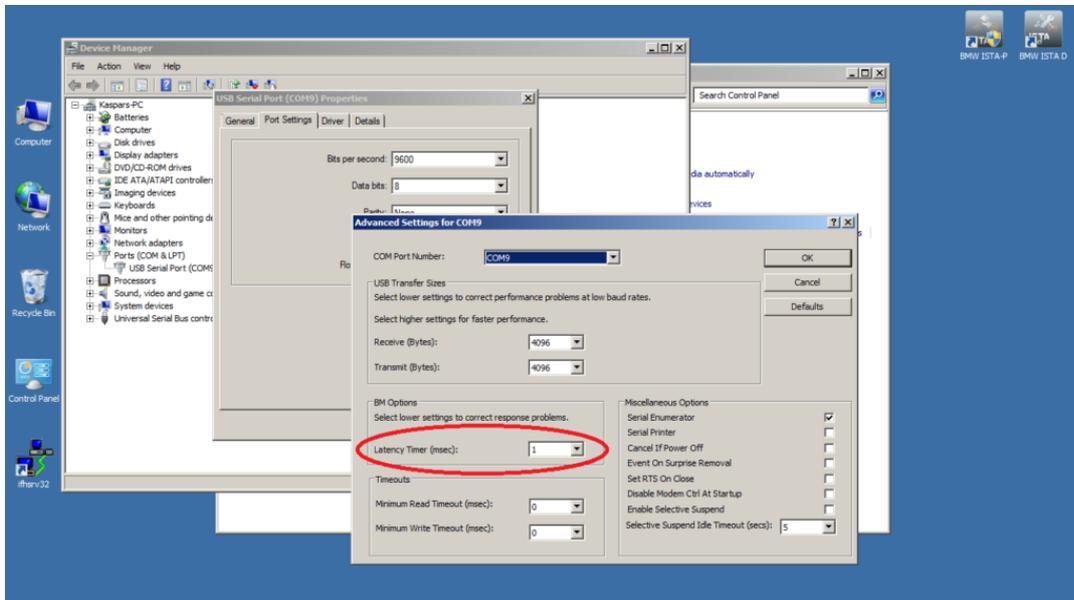
1. Connect OBD/USB cable
2. Open: Control panel / Device manager
3. Select: Ports (LPT and COM)
4. Select: USB serial Port (COM X)
5. Enter sub-menu: Port settings / Advanced
6. Set Latency time to: 1 msec\*
7. Press OK, confirm changes

\*(default value: 16 msec)

2. Communication with INPA breaks regularly. Cause: Incorrect latency setting.  
Solution:
